Bus

★★★ **RECALL CAMPAIGN - SAFETY RISK RC No. 110701**

Checking the clamping force of the track rod

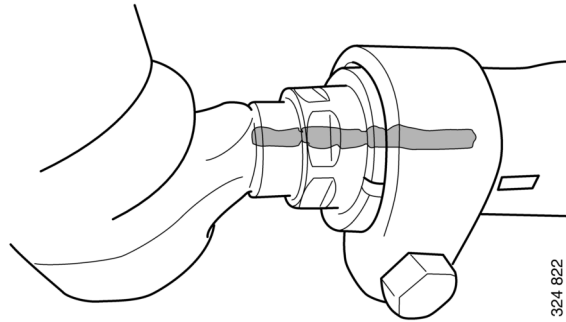
1. Check the clamping force of the track rod.
 - a. Lift and support the vehicle on stands to simplify the work on the track rod and the ball joint. For more information refer to *Scania Multi 00:00-50 Lifting and supporting on stands*.
 - b. Mark the positions of the ball joint and the adjusting sleeve.

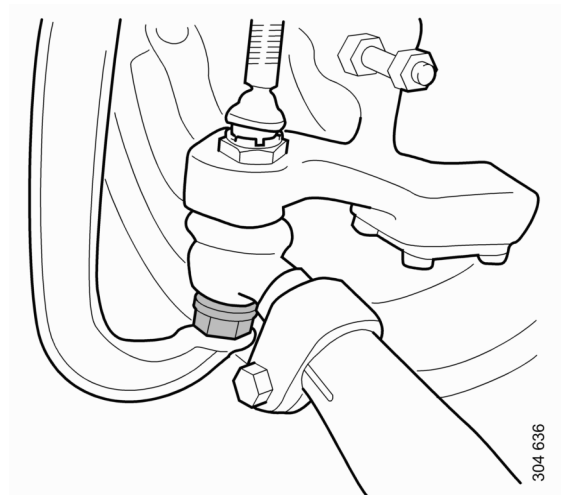
- d. Try to turn the track rod using for example a pipe wrench.

Maximum length of the pipe wrench must not be longer than 30 cm.

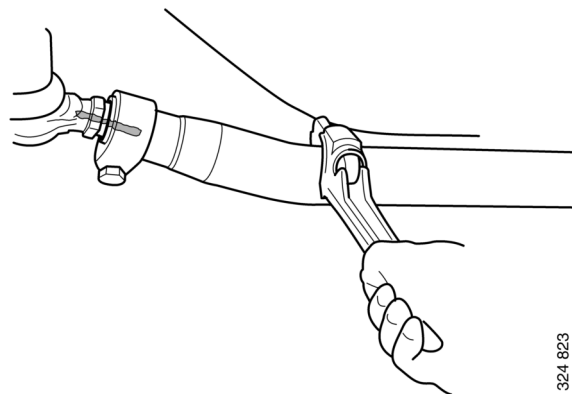
Check that the ball joint and the track rod move as one unit by observing the markings.
